HICKORY HOLLOW LAKE DAM

PERRY COUNTY, MISSOURI

MO 31068

PHASE 1 INSPECTION REPORT NATIONAL DAM SAFETY PROGRAM

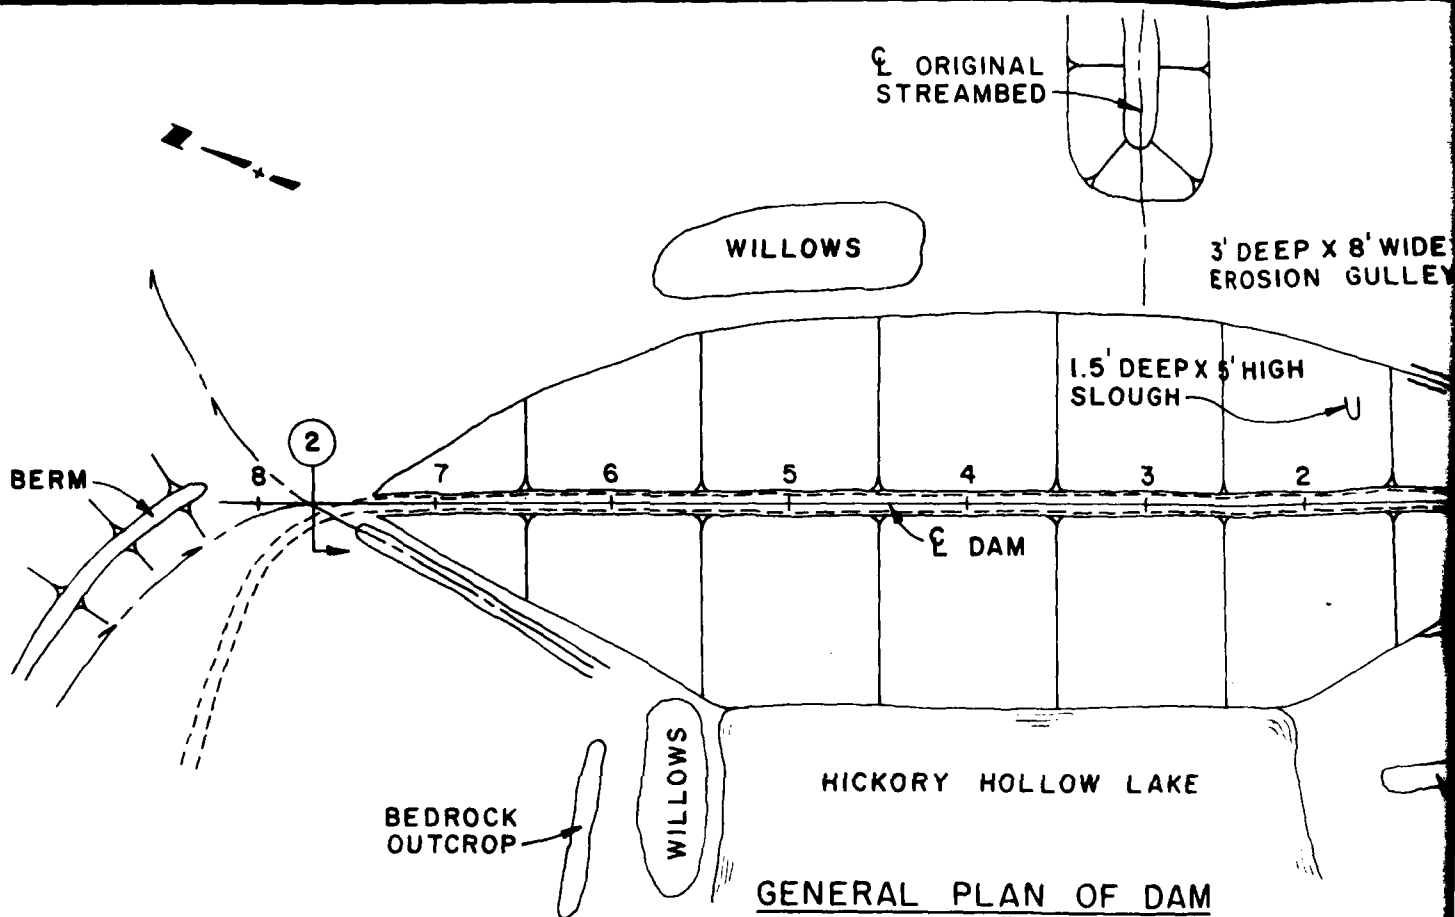
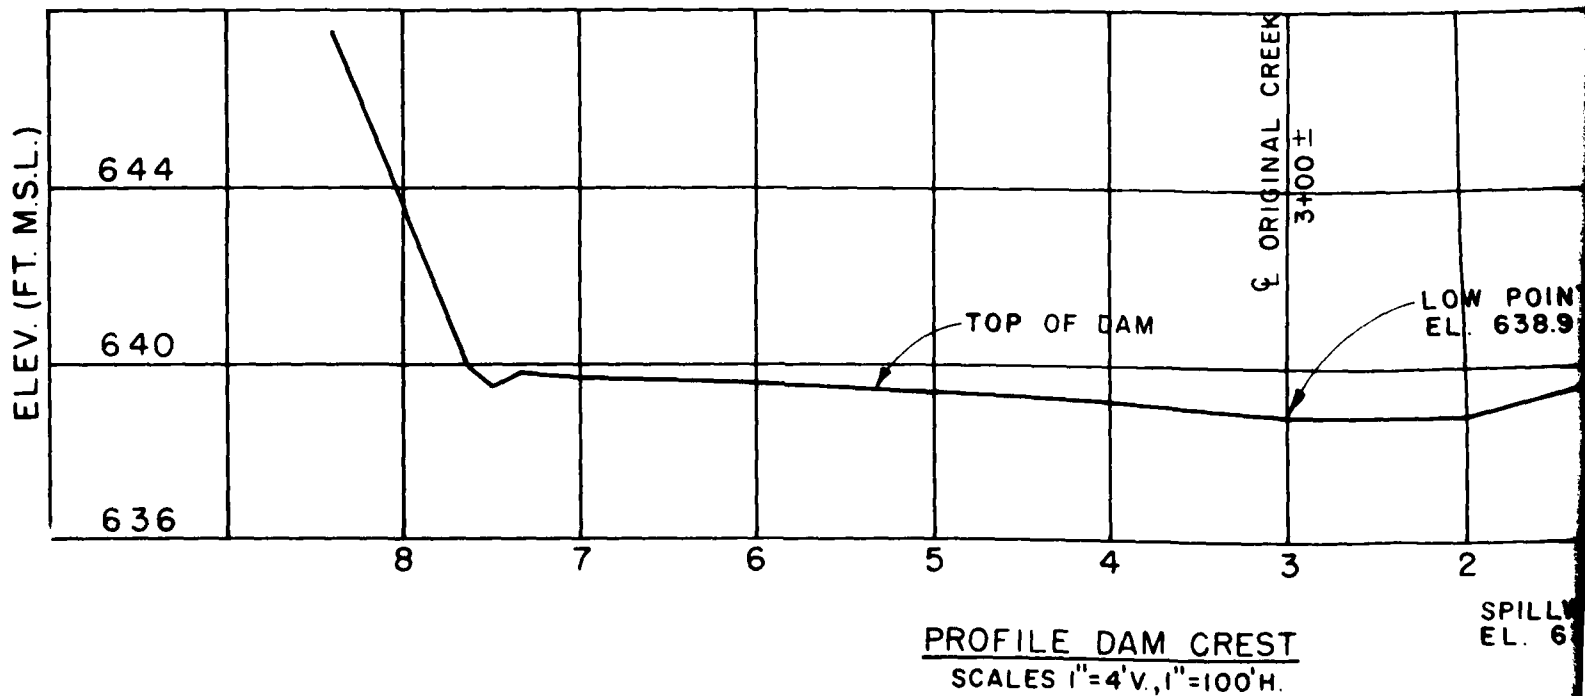
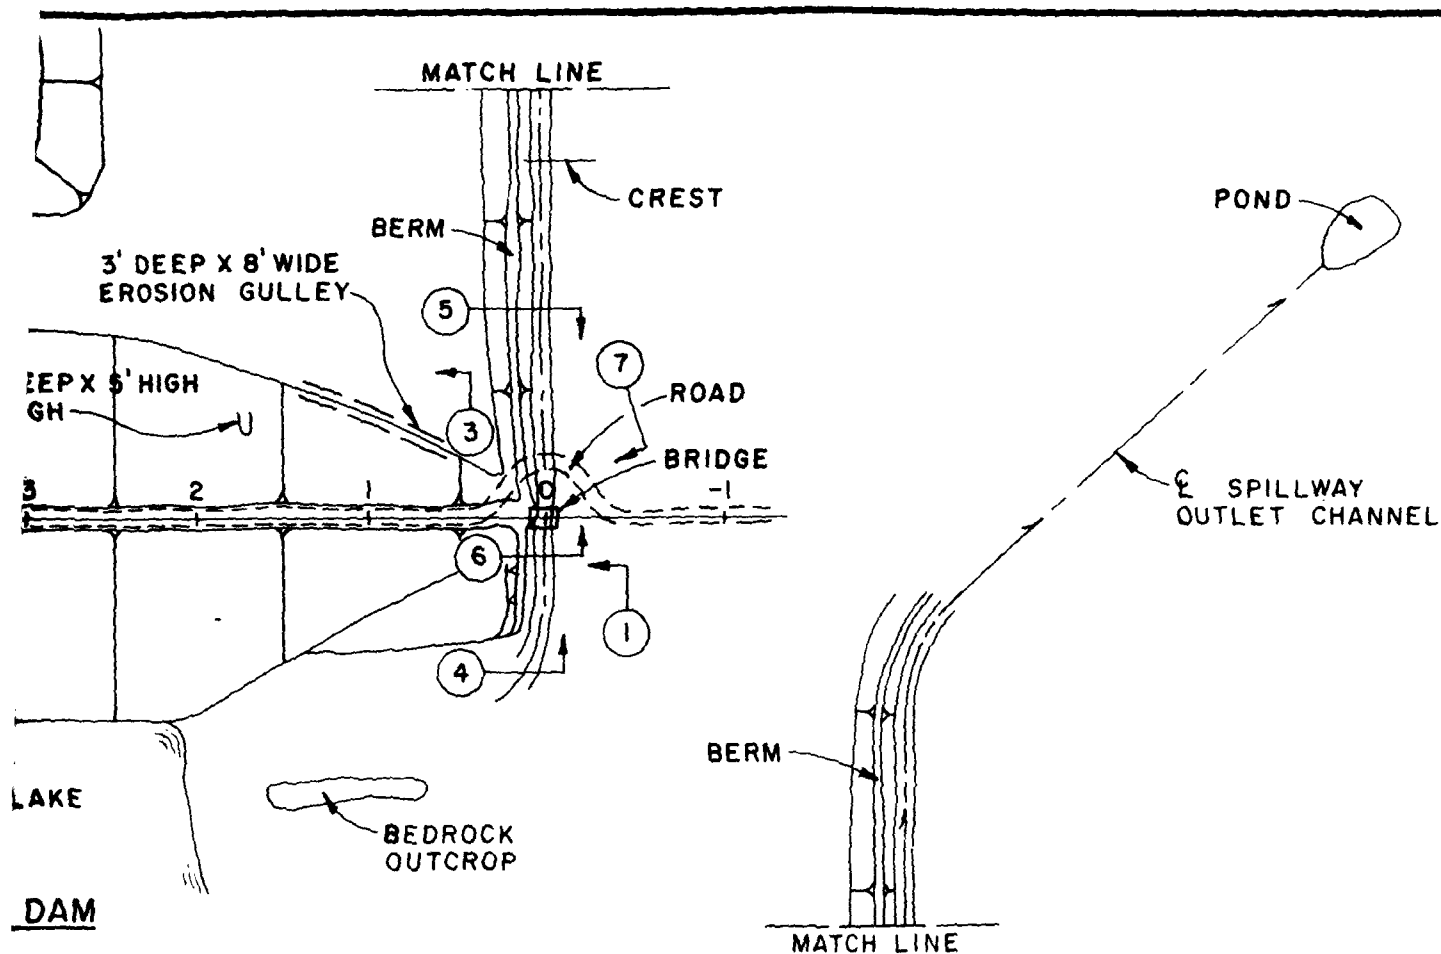
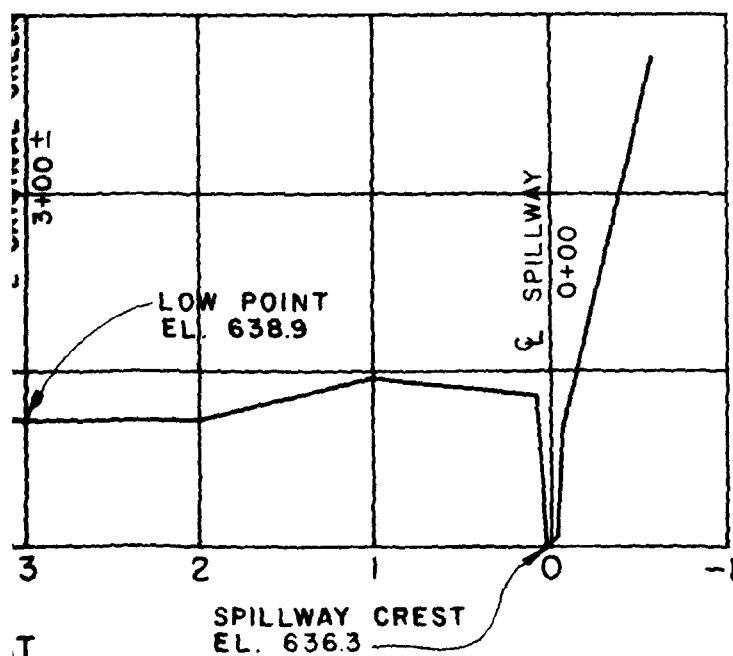
PLATE 3

PHOTO LOCATION & KEY
(SEE APPENDIX A)
